AGRONOMISTS' ASSOCIATIONTRIAL RESULTS

Cat. No.: 1848

CODE: MD S10/6/90/SW/IYSIS 'Zn'

TITLE: MOLE DRAINAGE IN A DUPLEX SOIL1. PARTICULARS OF PROJECT

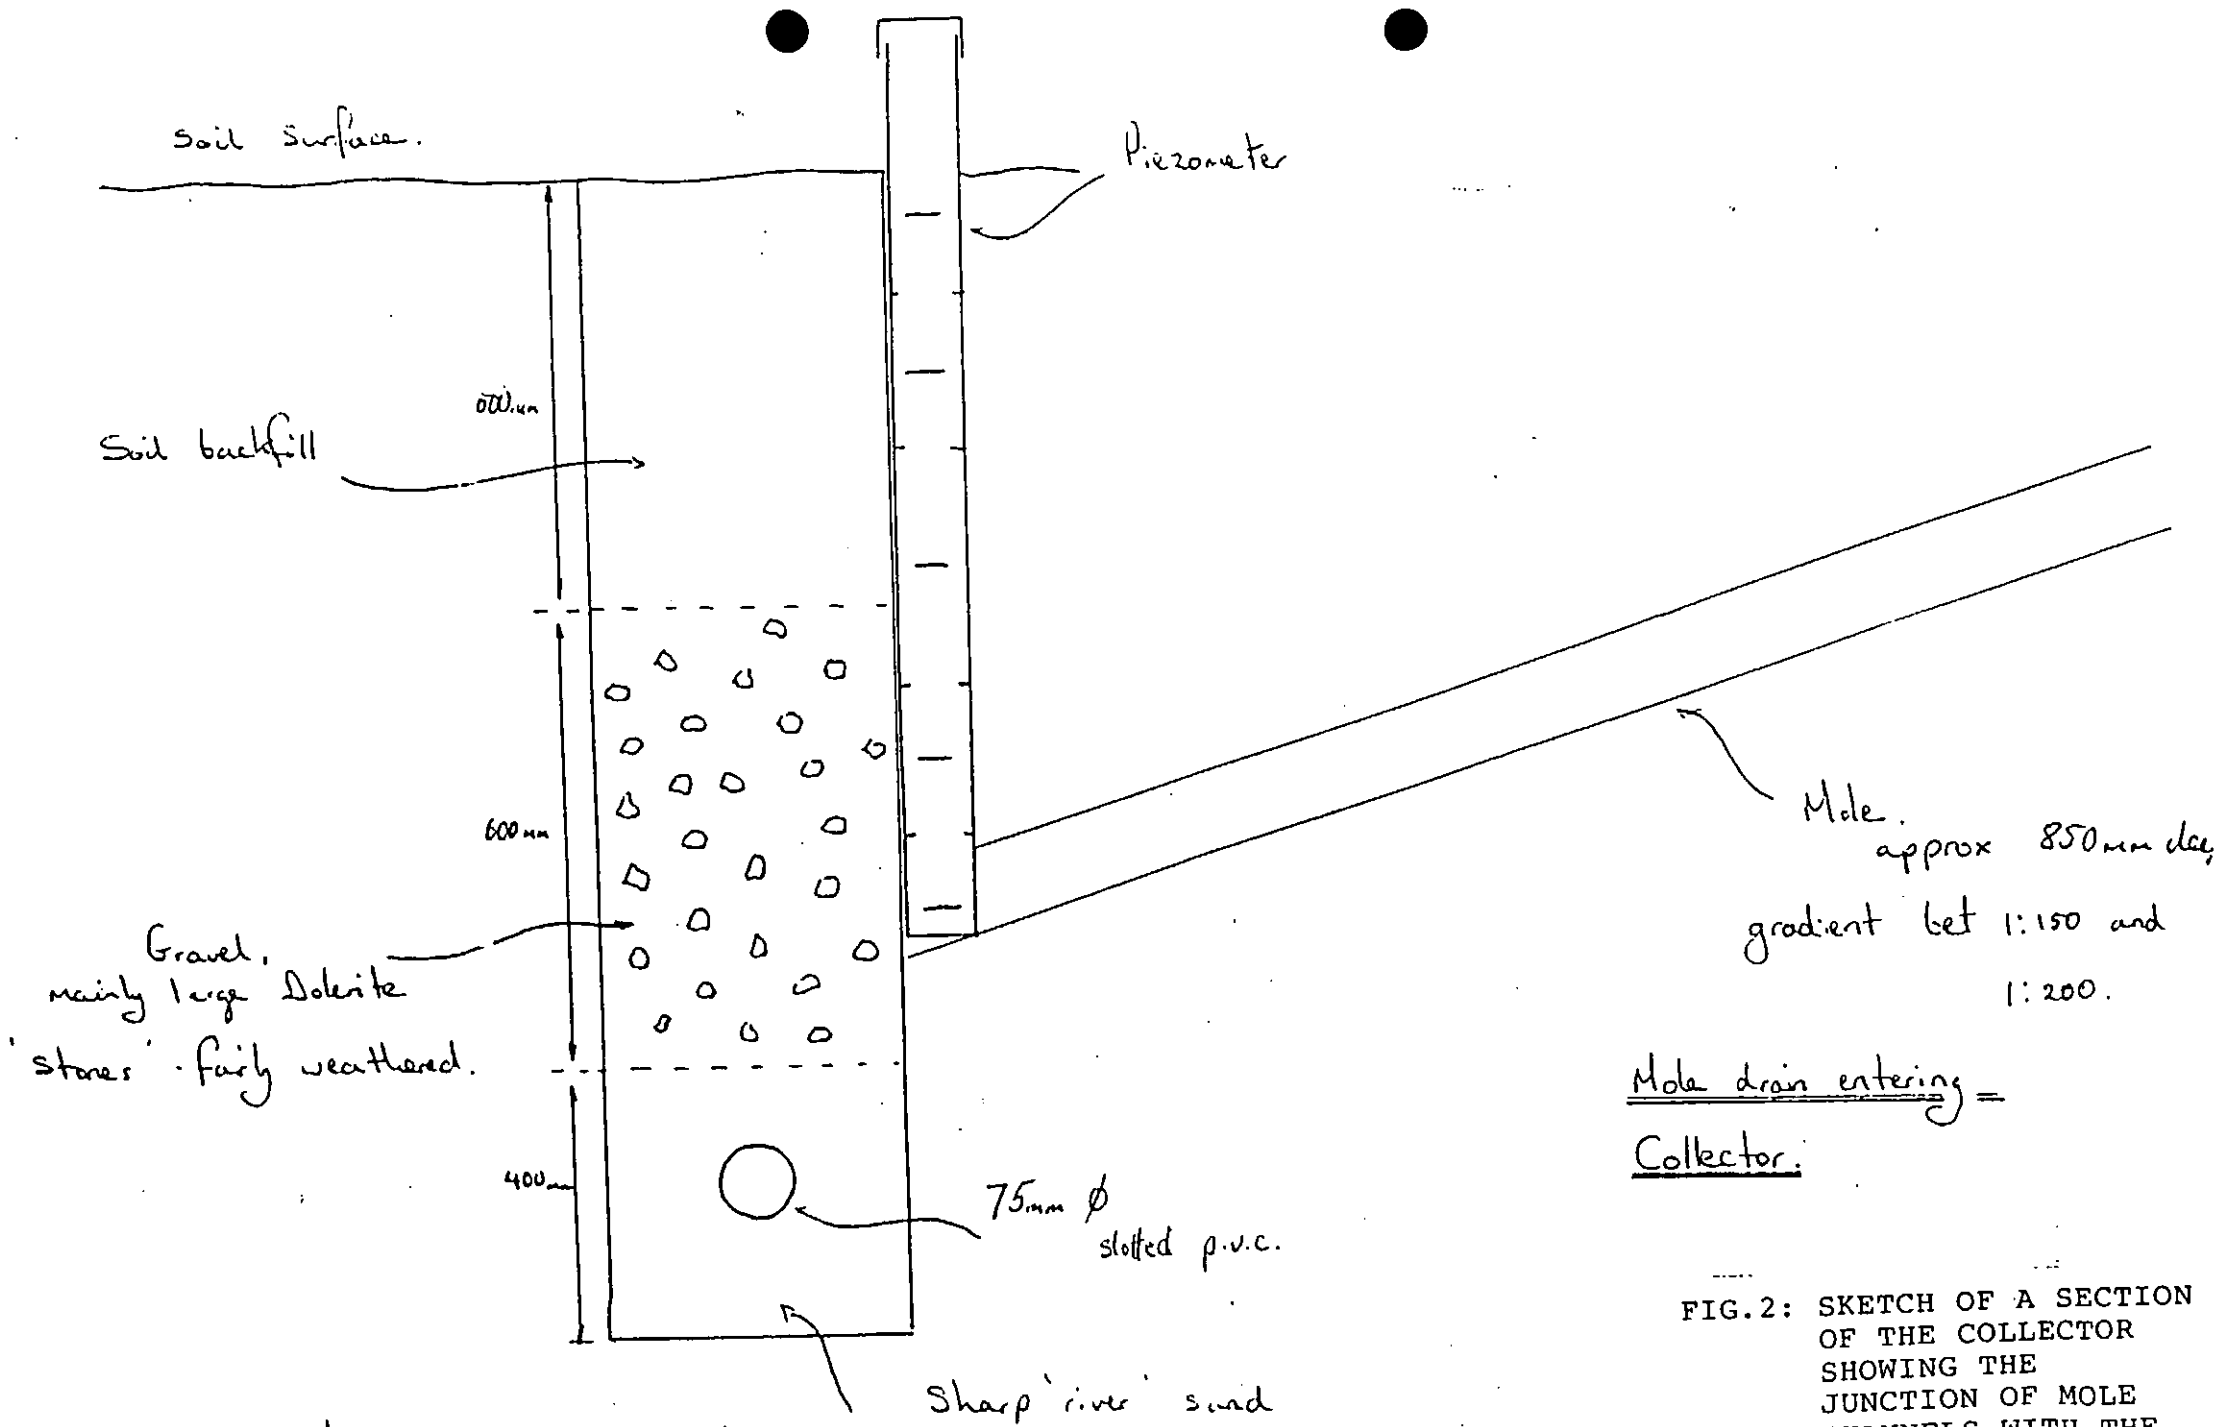
FIG. 2: SKETCH OF A SECTION OF THE COLLECTOR SHOWING THE JUNCTION OF MOLE CHANNELS WITH THE GRAVEL ENVELOPE AND LOCATION OF THE PIEZOMETER

If a drain works properly, no water should be found in the piezometer, that is the distance measured in the piezometer should be 90 cm (depth at which the drains were installed). The data in Table 1 show that for most drains this was not the case. A day after irrigation, water at various depths was found in 70% of the piezometers, indicating that the flow of water in the majority of the drains was being obstructed. The magnitude of the obstruction was variable. It was slight where the water apparently drained within 48 hours (drains 16, 28, 35), heavy where it took a week (drains 59, 66) and permanent where drainage was never completed (drain 74).

There are two possible explanations for the slow flow of water in the drains. Firstly the Z set soils, being inherently high in Sodium content, have a tendency to disperse when irrigated with water of low electrolyte concentration. Thus, the fact that clean surface irrigation water flowed directly into the drains might have caused dispersion. The slurry of dispersed soil would have been washed into the gravel envelope blocking pores and or the channels themselves. The second possibility is that when the mole drains were pulled, soil was dragged across the gravel layer creating a local seal.

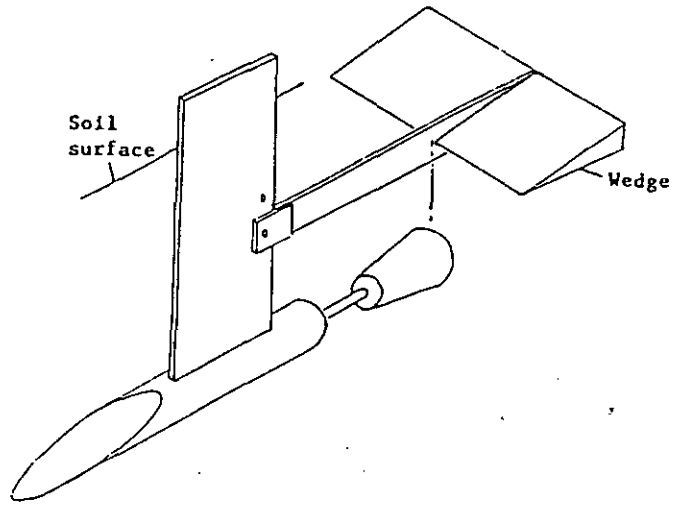
FIG. 3 : MOLE PLOUGH WEDGE FOR DISRUPTING
LEG SLOT AND FISSURES

The mole plough was fitted with a wedge shaped attachment behind and above the mole bullet (Fig.3). The purpose of this attachment was to attempt sealing the leg slot by compaction.

- * Raise the wedge attachment so that the leg slot be sealed nearer the soil surface.
- * Means of ensuring that when travelling the mole plough is levelled will have to be devised.
- * Fit a small tine behind the expander to prevent smearing the collector envelopes with soil when pulling the mole plough.

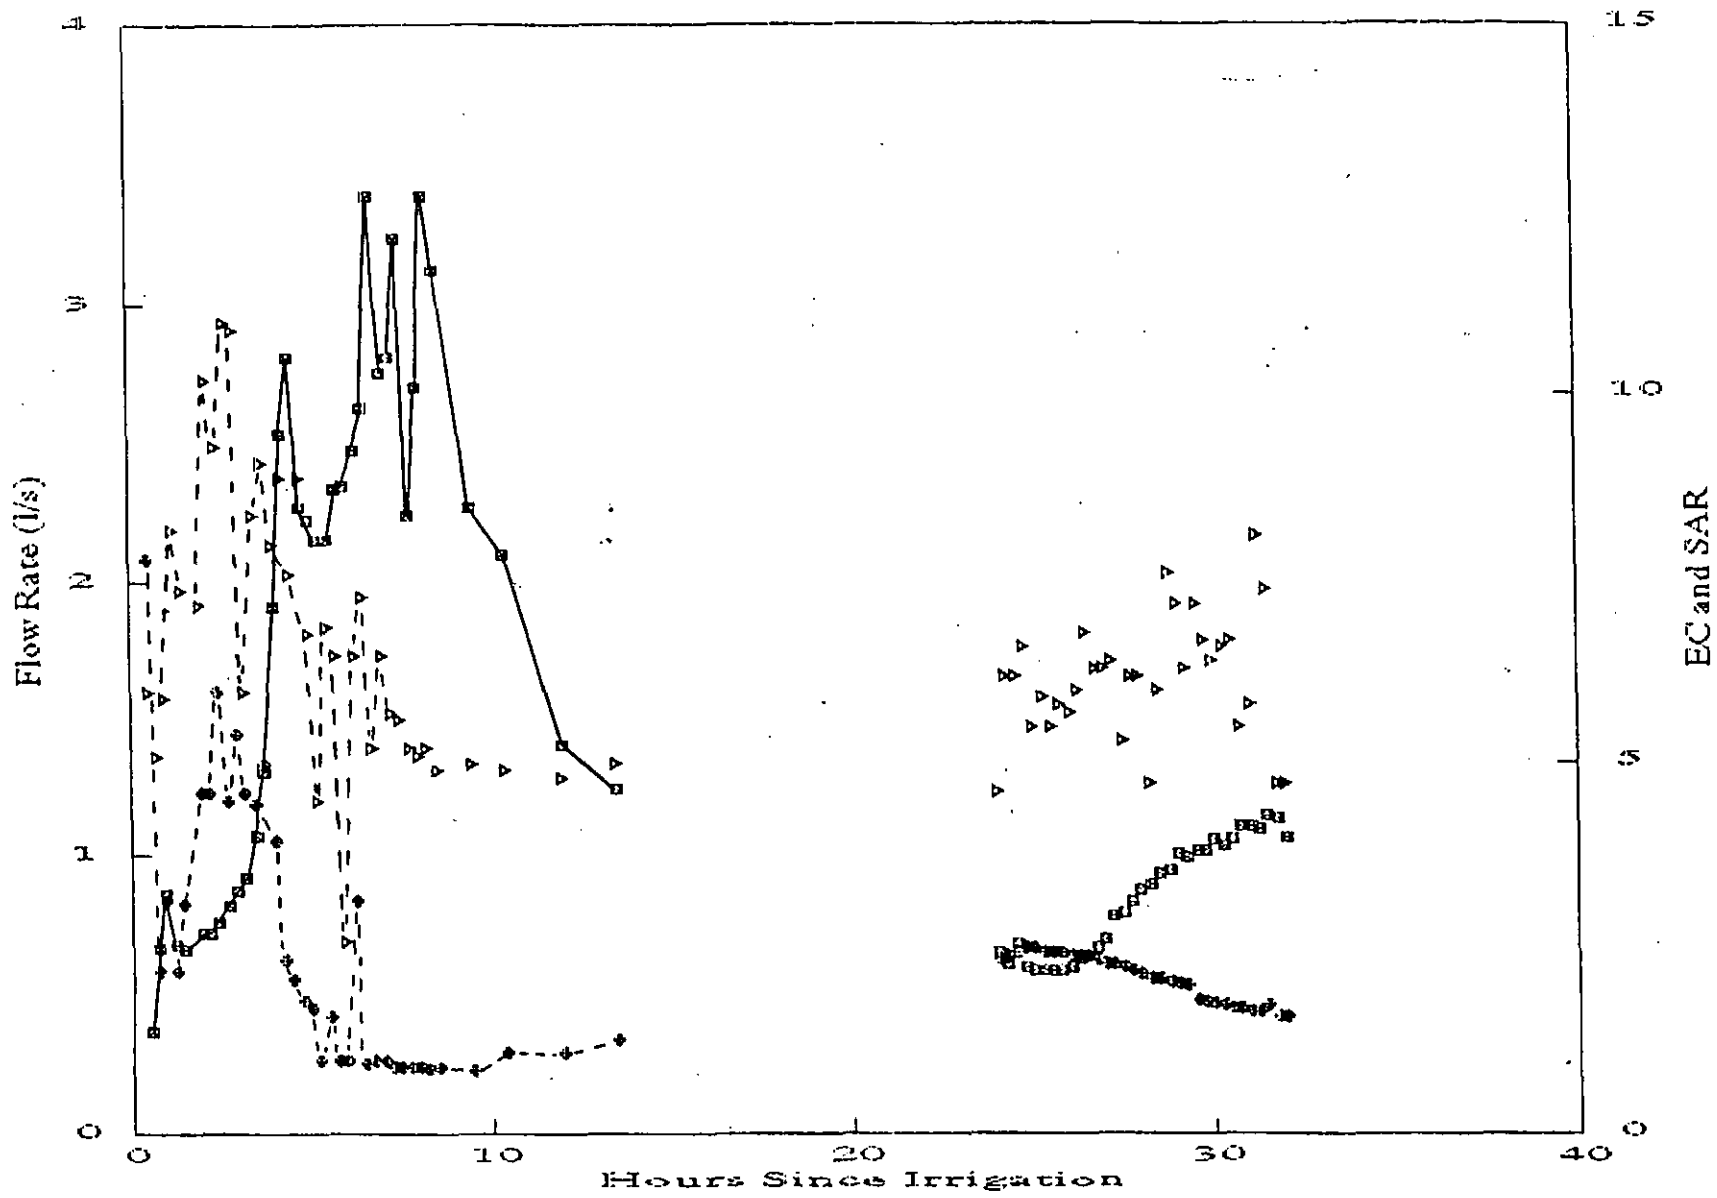
FIG. 4: PATTERNS OF DISCHARGE FLOW RATE, EC AND SAR OBSERVED AT THE COLLECTOR AFTER AN IRRIGATION EVENT.

Fig.4 shows typical patterns of discharge flow rates, EC and SAR observed in the collector after an irrigation event. The discharge flow rate is shown to increase dramatically within hours of commencement of irrigation. The flow rate peaked several times before abating +/- 10 hours after the onset of irrigation. EC and SAR both followed inverse patterns to that of the flow rate i.e. when the flow rate peaked EC and SAR were at a minimum and vice versa. 24 hours later the discharge flow rate is seen to increase again but this time in a steadily manner. At 30 hours the flow rate appears to have reached a plateau. In apparent response to the increase in flow rate, EC decreased slightly.

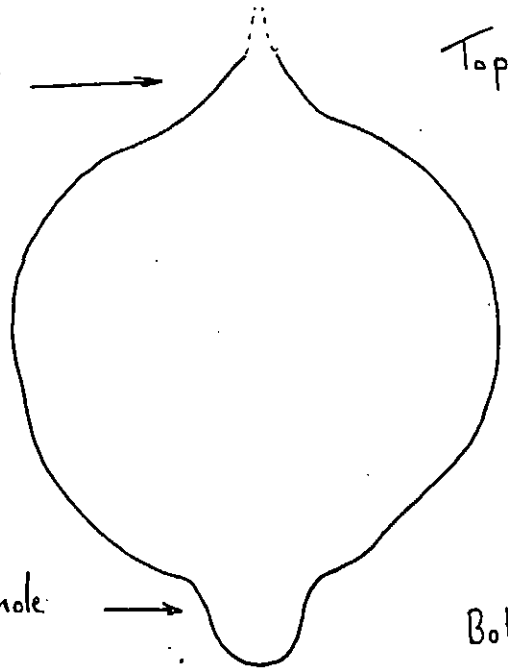
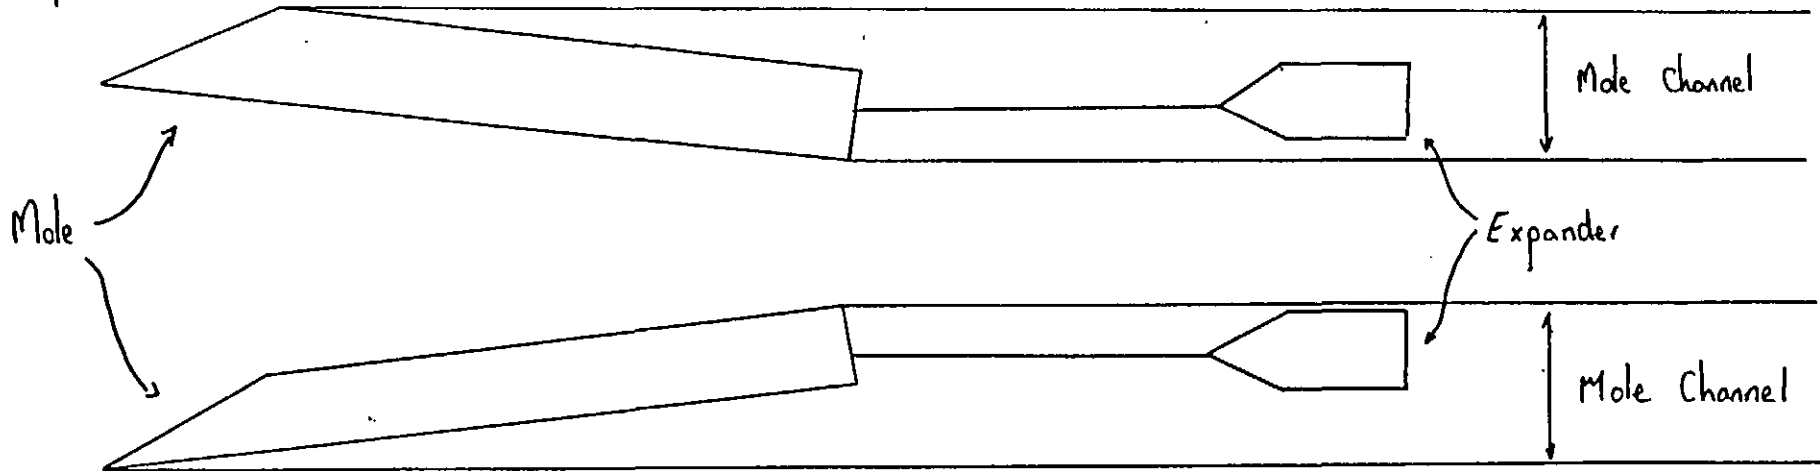
FIG. 5: SHOWING CONSEQUENCES OF AN INCORRECTLY ANGLED MOLE PLOUGH ON CHANNEL SHAPE

- * The end of all three mole channels were filled with slurry. In one case it was found that the whole channel had collapsed and filled with slurry. This slurry accounts for the slow flow of water in the drain and explains the piezometer observations.
- * The shape of channels instead of a circular shape was of a rather distorted oval shape. Fig. 5 shows the approximate shape of the channel and the angle at which the mole plough must have travelled. This is a flaw in the drain installation and one that can cause the drain to fail.

- * Visual inspection of excavated mole channels showed that the mole plough travelled at an angle. This problem is likely to have compounded that of direct surface water inflow and contributed to the weakening of the channels' stability.

Leg slot not compacted by expander

Gouge produced by tip or foot of mole

A: Mole angled upwards

B: Mole angled downwards
