AGRONOMISTS' ASSOCIATIONTRIAL RESULTS

Cat. No.: 1848

CODE: MD S10/6/90/SW/IYSIS 'Zn'

TITLE: MOLE DRAINAGE IN A DUPLEX SOIL1. PARTICULARS OF PROJECT

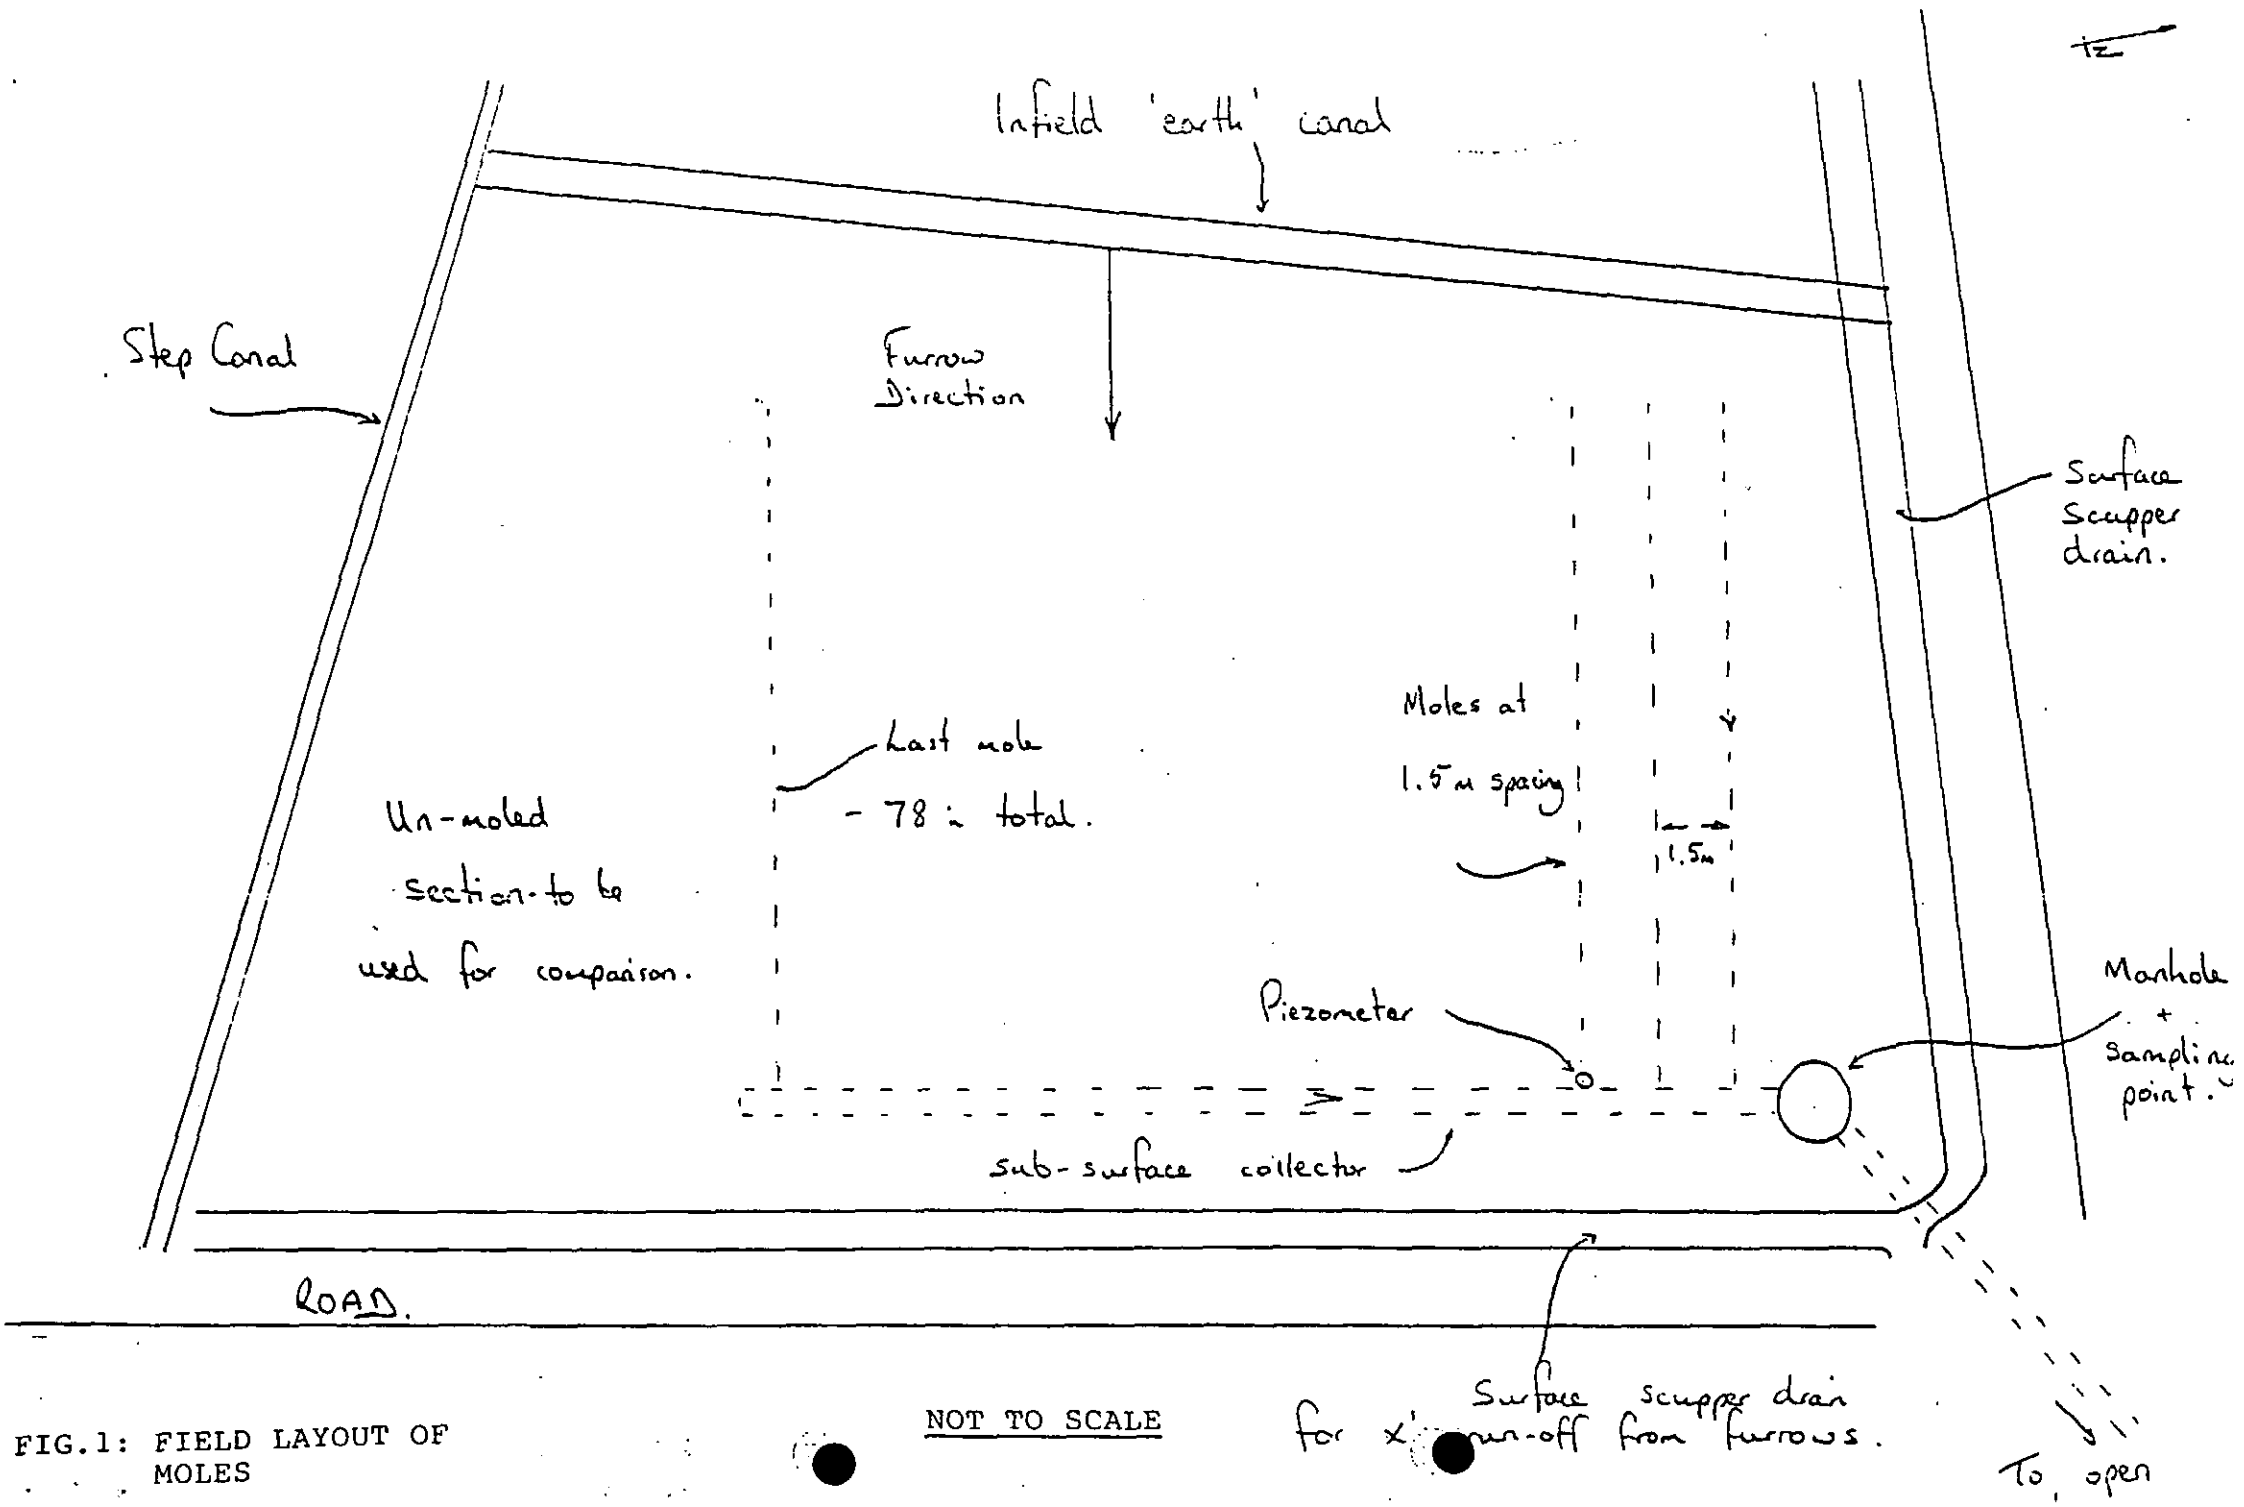
FIG. 1: FIELD LAYOUT OF MOLES

Seventy eight mole channels at 1.5 m spacing each 100 m long were drawn in-row at a depth of 0.9 m. The mole drains discharged in the gravel envelope of a specially constructed sub-surface collector drain (Fig.1). The collector could be accessed from a manhole.
